National Register of Historic Places
Registration Form

historic name Fruit Row

street & number Both sides of North First Avenue, from West Yakima Avenue north to West D Street

city or town Yakima

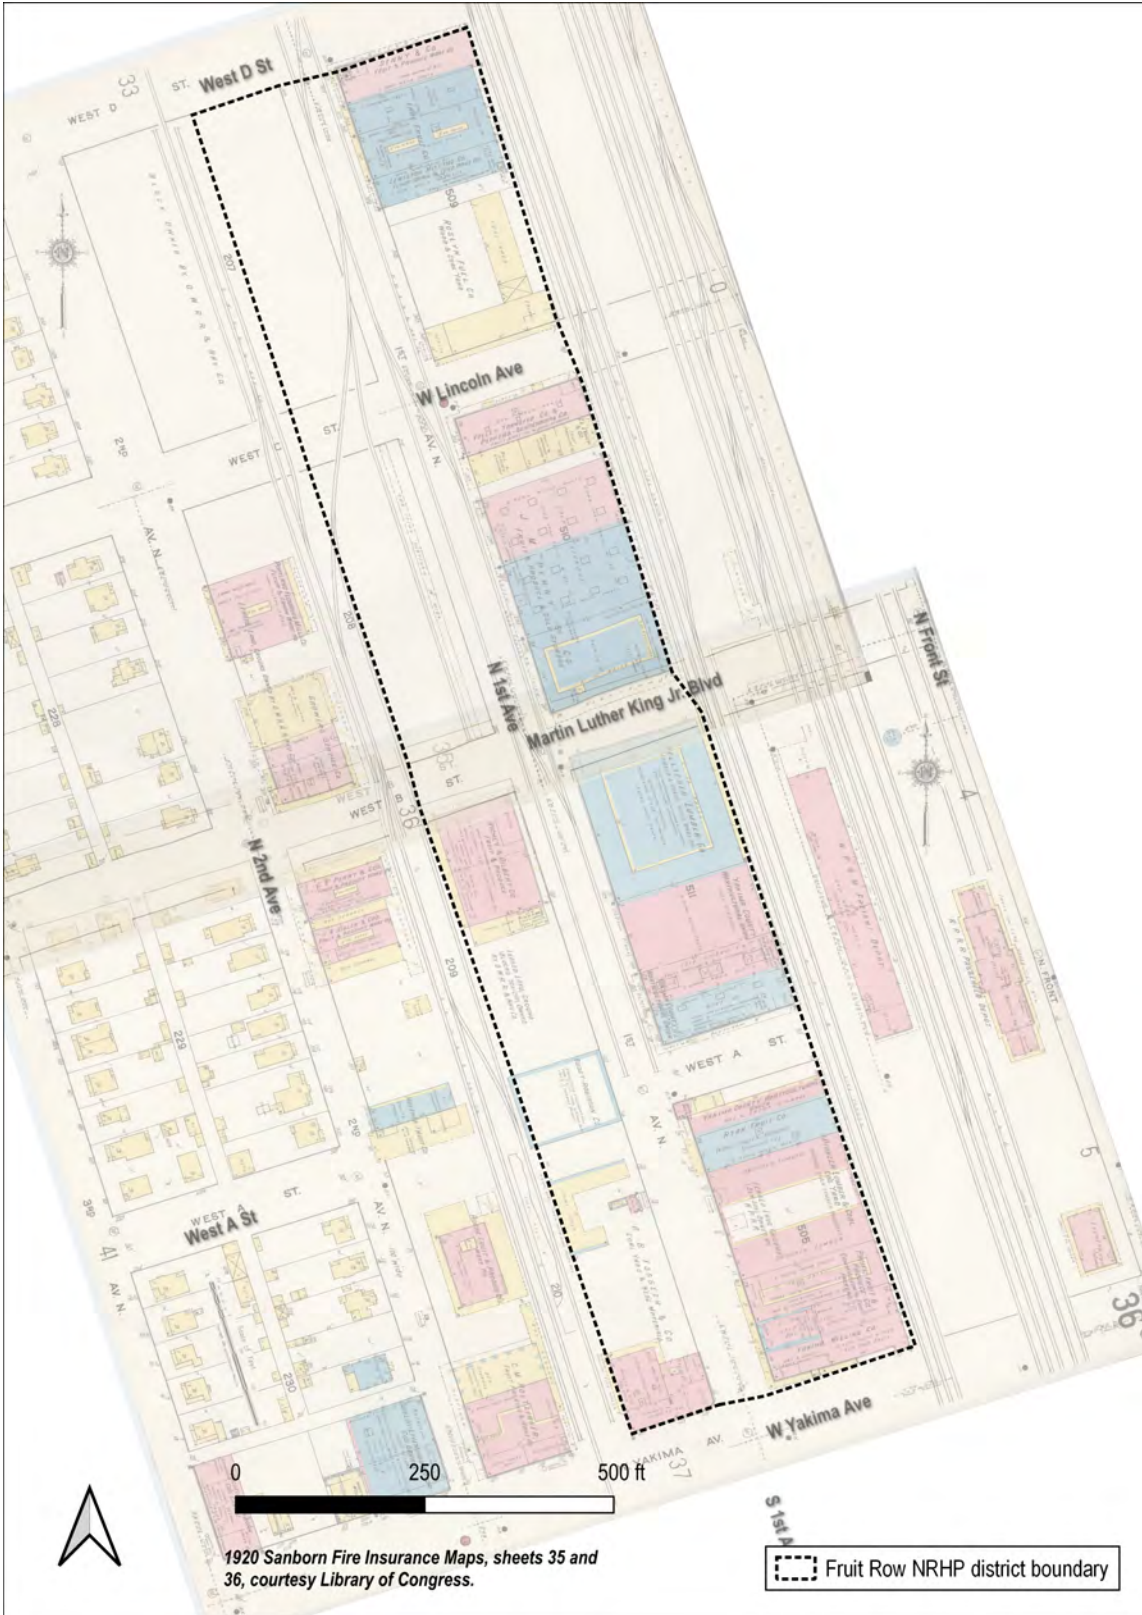
Map 17. 1920
Sanborn.

1920 Sanborn Fire Insurance Maps, sheets 35 and 36, courtesy Library of Congress.

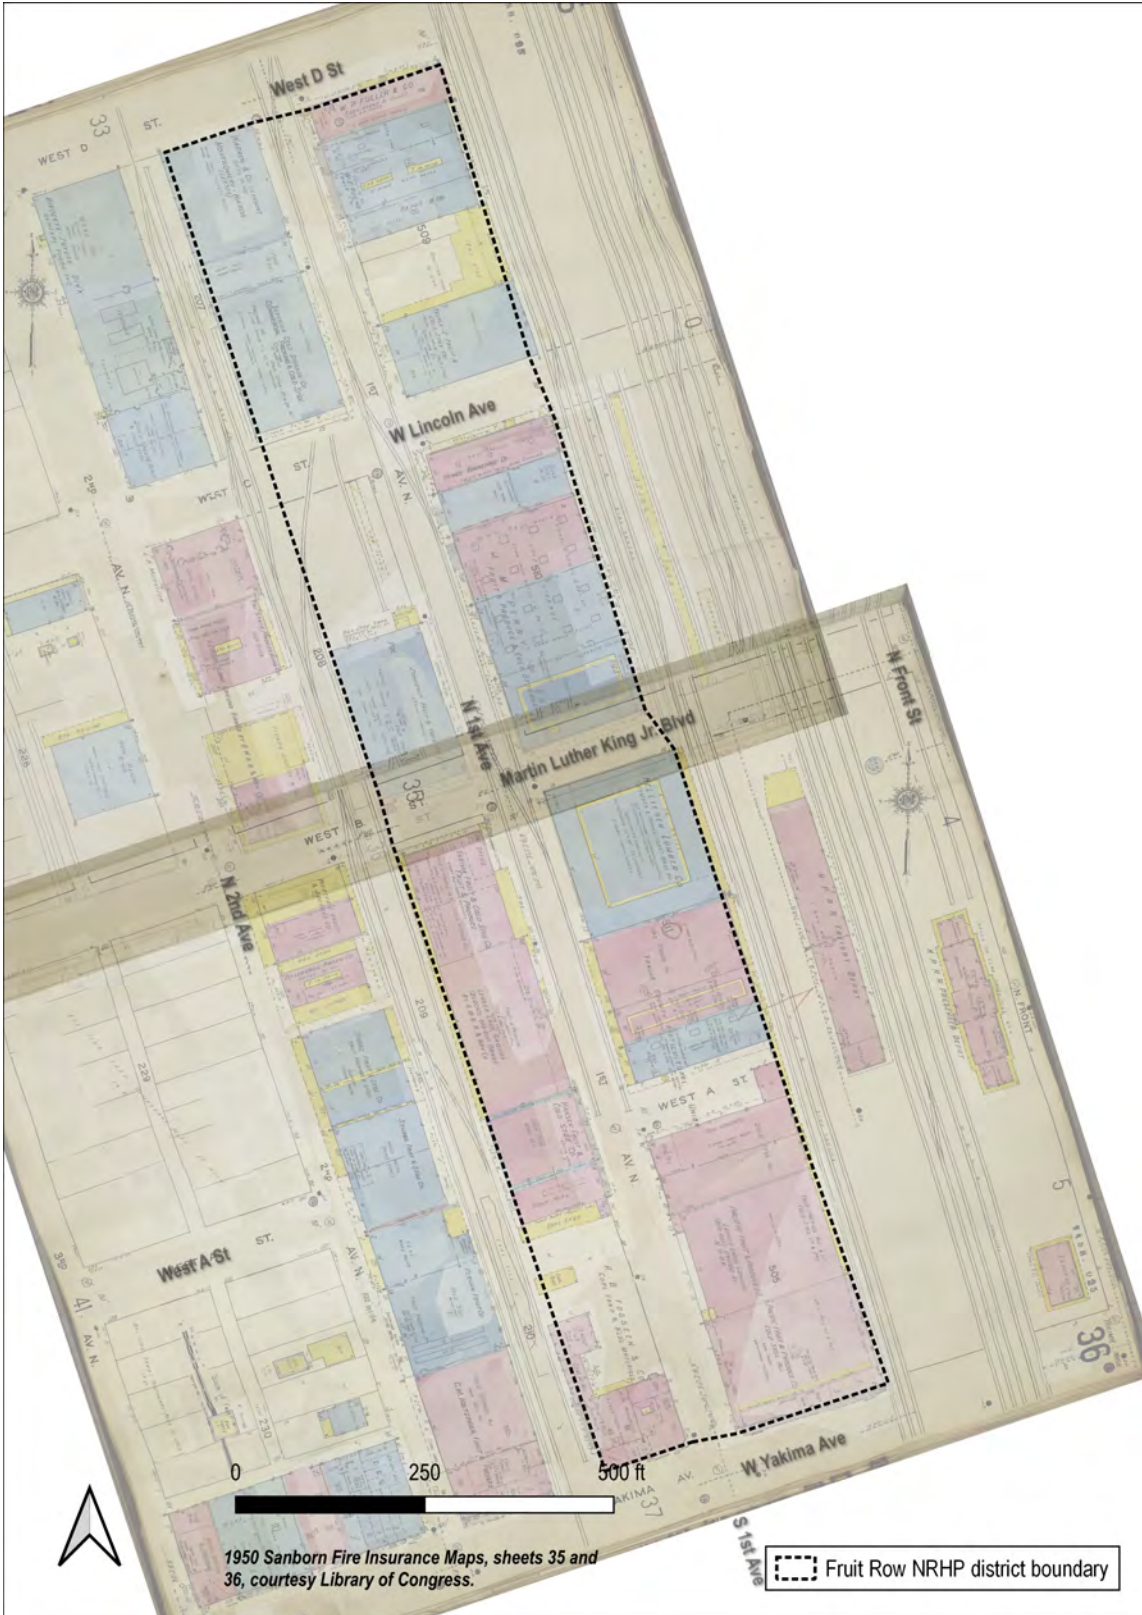
Map 18. 1950
Sanborn.

1950 Sanborn Fire Insurance Maps, sheets 35 and 36, courtesy Library of Congress.

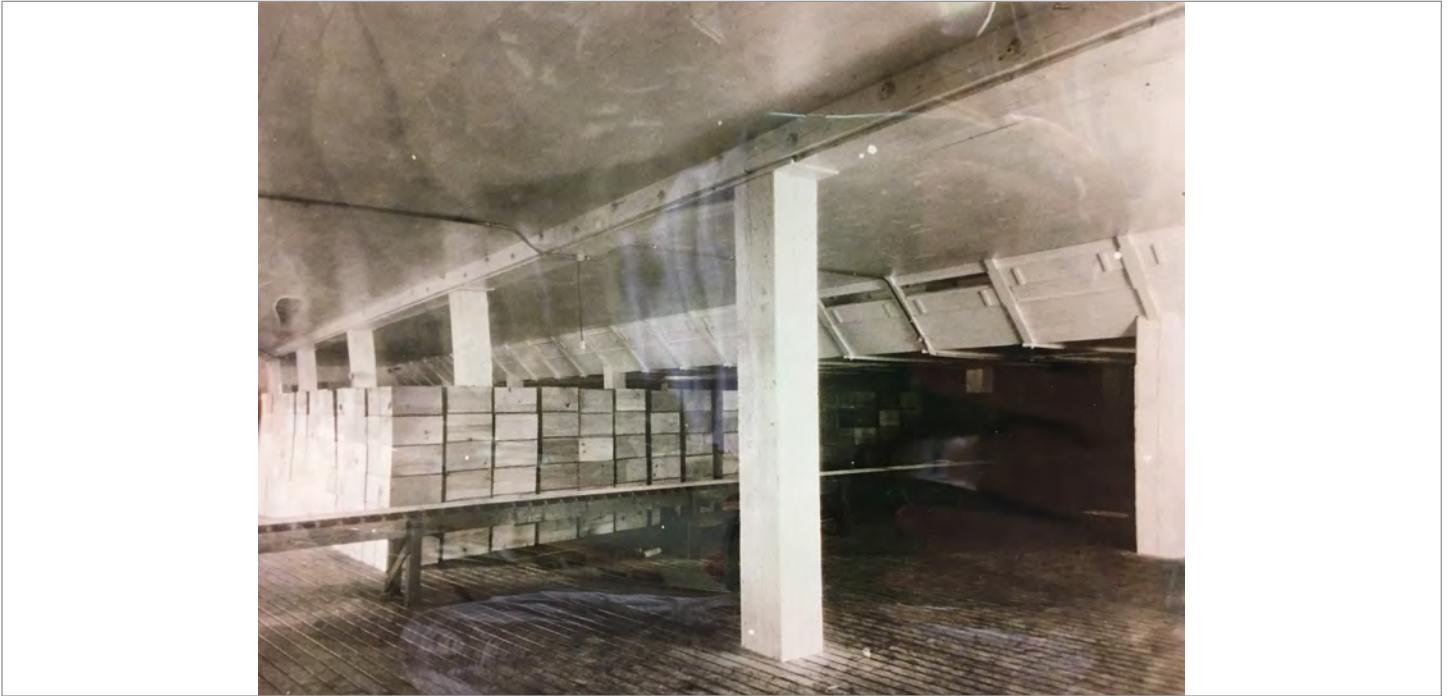
Undated view of the interior of the Wiley Warehouse showing typical storage conditions. Source: Yakima Valley Museum, Accession Number 2005-800-048.

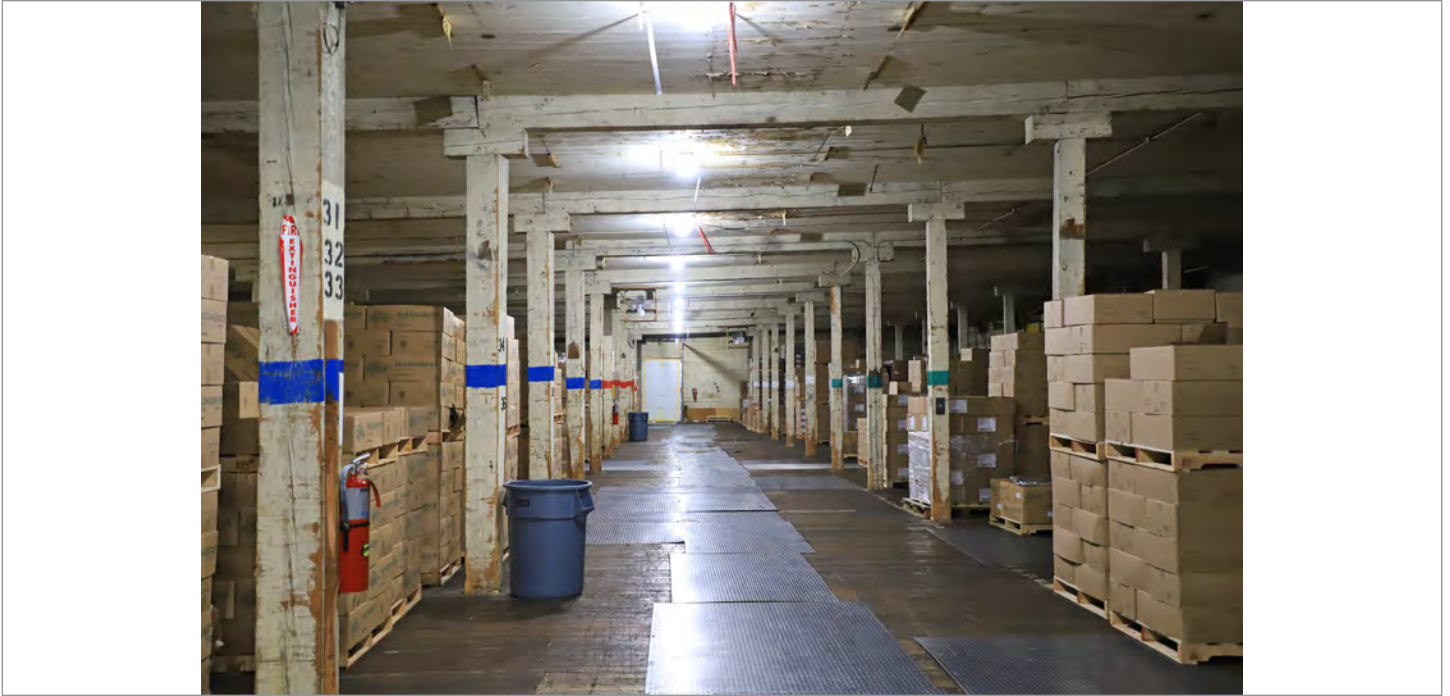
WA_Yakima County_Fruit Row_0023. Interior looking north within 202 N First Avenue.

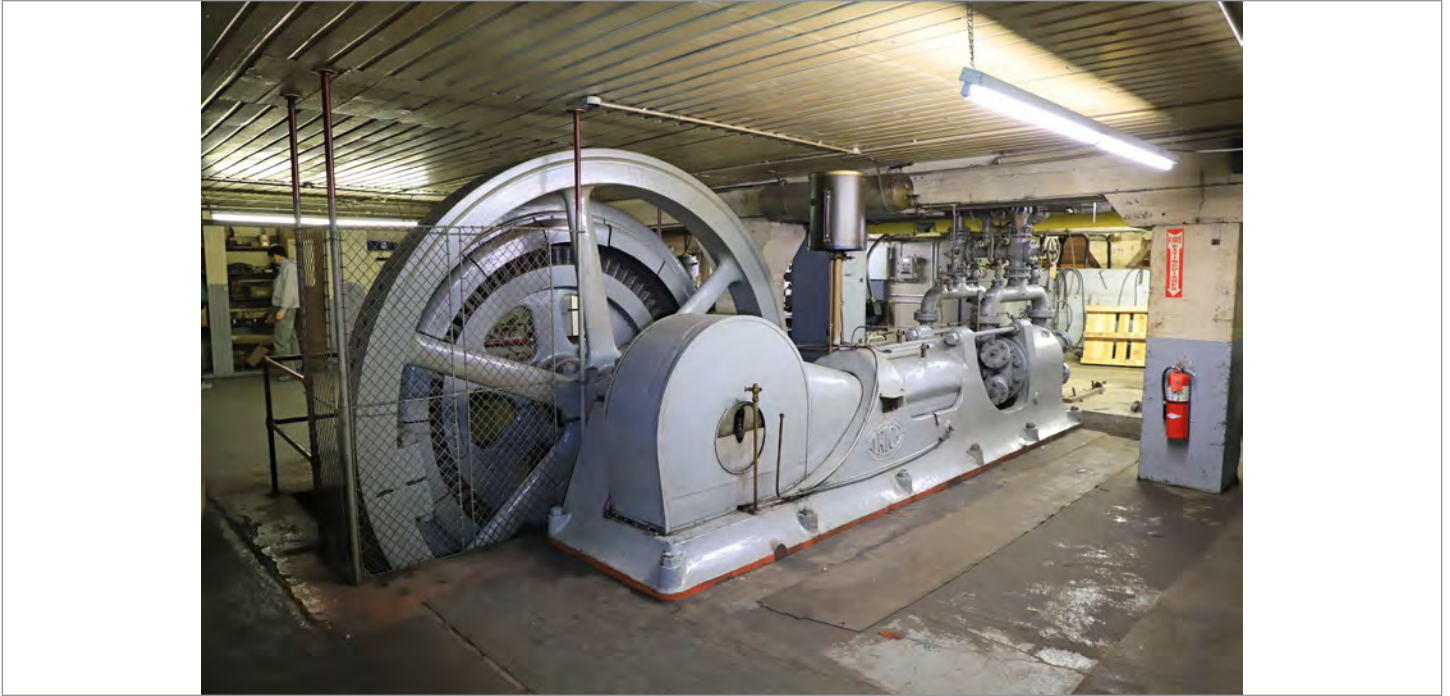
WA_Yakima County_Fruit Row_0025. Ammonia compressor in basement of 201 N First Avenue.
